OZONE-INDUCED CRACK ON BASE-ISOLATED NATURAL RUBBER BEARING SUBJECTED TO EXTERNAL LOADS AND ITS REPAIR

Yoshito Itoh¹, Mikihiro Hirohata² and Katsuyuki Fujimoto³

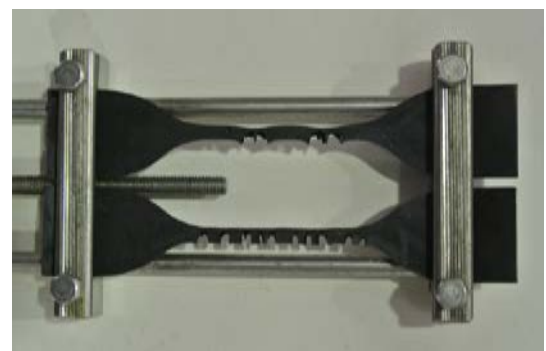
Figure 5: Damaged dumbbell specimen (condition (5), pre-strain 80%)

in the case that the temperature was more heightened to 23 degrees Celsius and the ozone density was decreased to 50 pphm, cracks did not occur regardless of the magnitude of pre-strain after the experiment of 192 hours (the condition (4)). Based on these results, the experiment was performed by the condition (5), of which the temperature was 23 degrees Celsius and the ozone density was 100 pphm. Then, cracks or breaking occurred earlier according to the magnitude of pre-strain.

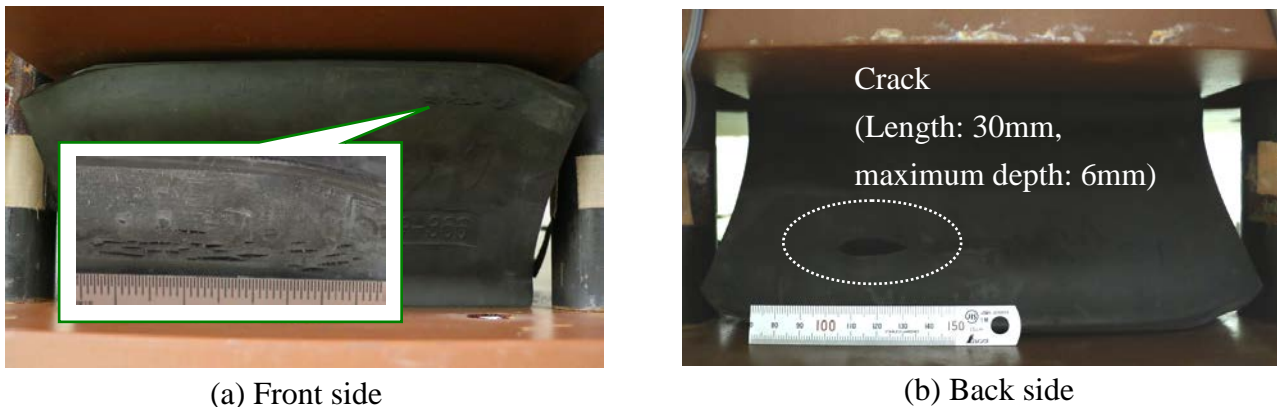
The accelerated exposure experiment was performed on the bearing specimen under the condition of which the temperature was 23 degrees Celsius and the ozone density was 100 pphm. However, cracks did not occur on the surface of specimen after the experiment of 96 hours. It might be thought that the resistance toward ozone attack of the bearing specimen was higher than that of the dumbbell specimens of which the thickness was just 2 mm and which is subjected to ozone attack from the both surfaces. Therefore, the temperature was heightened to 40 degrees Celsius and the experiment was carried out again. As a result, cracks were observed as shown in Figure 6 after the experiment of 384 hours. The crack occurrence positions were corresponded to the region in which the high tensile strain was locally applied. The maximum length and depth of crack obtained by this experiment were around 30 mm and 6 mm respectively. The cracks stopped in the surface cover rubber and they did not reach the rubber layers inside the bearing specimen.

Figure 6: Cracks of bearing specimen

The cracks of bearing specimen generated by the accelerated exposure experiment were repaired by CSM (Chlorosulfonated polyethylene) coating. Figure 7 shows the flow of crack repair. Firstly, the steel frame for applying the shear deformation on the bearing specimen was removed. The region around the small cracks were cleaned and primed. And then, the cracks were covered by the CSM coating. In the case of the large crack, the crack was removed by grinding, and then the

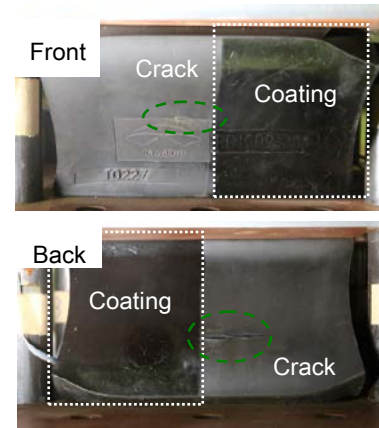
Figure 8: Cracks of repaired specimen

The accelerated exposure experiment was applied on the bearing specimen of which the cracks were repaired by the CSM coating. The experimental condition was the temperature of 23 degrees Celsius and the ozone density of 100 pphm. Figure 8 shows the appearance of specimen after the experiment. The new cracks were generated in the regions without coating after 192 hours of the experiment. However, no crack was re-generated in the repaired region by the CSM coating even after 384 hours of the experiment. The experimental results showed the repair performance of the CSM coating.
