Investigation for crack on base-isolated rubber bearing subjected to environmental degradation factors and external loads

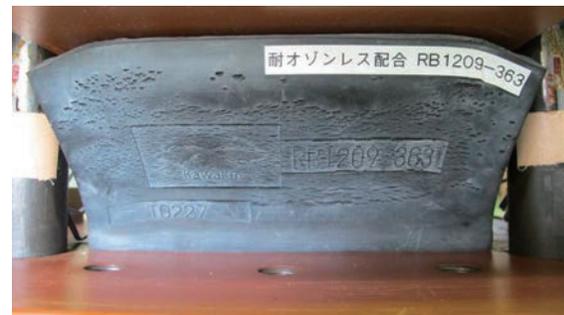
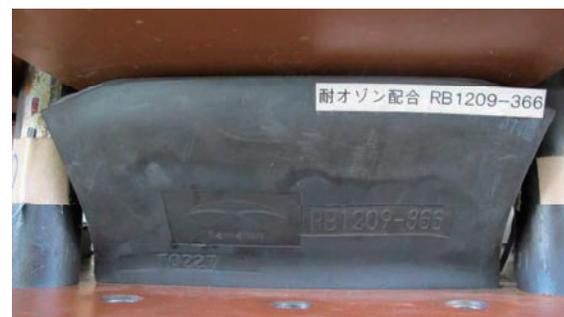
Fig. 6: Experimental results under the low temperature condition

Fig. 6 shows the appearances of the bearing specimens after finishing 5 cycles of the accelerated exposure experiment. The surfaces crossing to the shear deformation direction of the bearing specimen are shown.

A lot of cracks were generated on the surface of the bearing specimen without anti-aging agent during 2 hours from the start of experiment. The number of cracks increased with time

passage after that. The cracks observed in not only surfaces crossing to the shear deformation direction, but also all surfaces. That is, the cracks were generated regardless of the strain distribution on the surfaces of bearing specimens. On the other hand, no crack could be observed in the bearing specimen with anti-aging agent during 5 cycles of the accelerated exposure experiment. The results indicated that the effectiveness of anti-aging agent used in the natural rubber bearings under the low temperature condition. In other words, the reason of crack occurrence recently reported in the actual natural rubber bearings of bridges is not the lack of anti-aging agent. Therefore, the accelerated exposure experiment is performed under the different temperature conditions for identifying the condition by which cracks are generated on the surface of the bearing specimen.

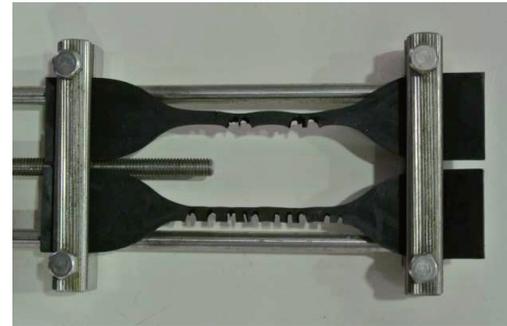
Fig. 7: Damaged dumbbell specimen (23 degrees Celsius, Ozone 100 pphm, pre-strain 80%)

Table 2 and *Fig. 7* show the experimental results. X in *Table 2* means the obvious crack occurrence or break of dumbbell specimens. On the other hand, the bar means that cracks could not be observed by visual checks and even the microscope.

No crack could be observed after finishing 96 hours of the experiment under the condition (1), of which the temperature was a little higher than that examined in the chapter 3. When the temperature was a little rose up by the condition (2), cracks were generated and the dumbbell specimens were broken at 24 hours in the cases with pre-strain of 75 %. That is to say, cracks easily occur under the not so low temperature condition such as 0 degrees Celsius rather than the low temperature condition of -30 degrees Celsius when the high ozone density and the pre-strain are applied. However, in the case that the temperature was more rose up to 23 degrees Celsius and the ozone density was decreased to 50 pphm, cracks did not occur regardless of the magnitude of pre-strain after the experiment of 192 hours (the condition (3)). Based on these results, the

experiment was performed by the condition (4), of which the temperature was 23 degrees Celsius and the ozone density was 100 pphm. As a result, cracks or breaking occurred earlier according to the magnitude of pre-strain.

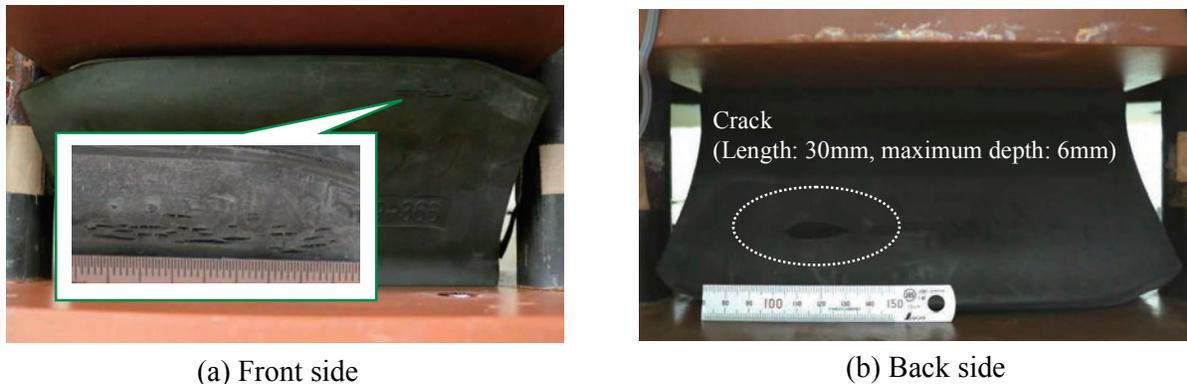
Fig. 8: Cracks of bearing specimen with anti-aging agent

The accelerated exposure experiment was performed on the bearing specimen with anti-aging agent under the condition of which the temperature was 23 degrees Celsius and the ozone density was 100 pphm. However, cracks did not occur on the surface of specimen after the experiment of 96 hours. It might be thought that the resistance toward ozone attack of the bearing specimen was higher than that of the dumbbell specimens of which the thickness was just 2 mm and which is subjected to ozone attack from the both surfaces. Therefore, the temperature was rose up to 40 degrees Celsius and the experiment was carried out again. As a result, cracks were observed as shown in Fig. 8 after the experiment of 384 hours. The position of crack occurrence corresponded to the region in which the high tensile strain was applied. The features of cracks were almost the same as that observed in the actual rubber bearing used during 10 or more years in the general temperature sites. The maximum length and depth of crack obtained by this experiment were around 30 mm and 6 mm respectively. The cracks stopped in the surface cover rubber and they did not reach the rubber layers inside the bearing specimen.

- (3) Cracks occurred on the surface of bearing specimen with anti-aging agent under the high temperature (40 degrees Celsius) and high ozone density (100 pphm) condition. The cracks occurred in the region which the high tensile strain was applied on. The features of cracks were almost the same as that observed in the actual rubber bearing used during 10 or more years in the general temperature sites.
