APPLICABILITY OF RBSM METHOD IN SMALL MESH SPECIMENS

EXPERIMENTAL RESULTS

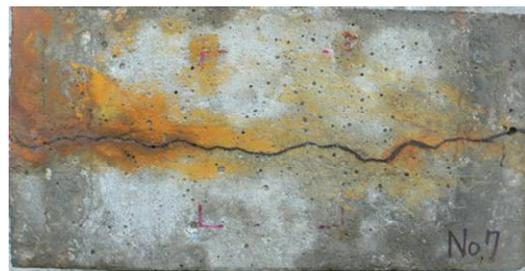
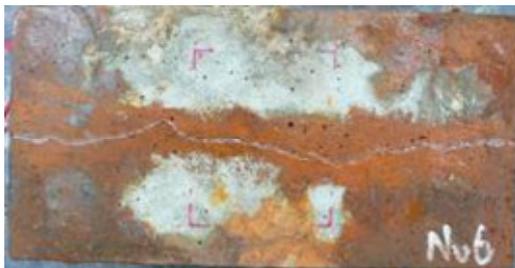
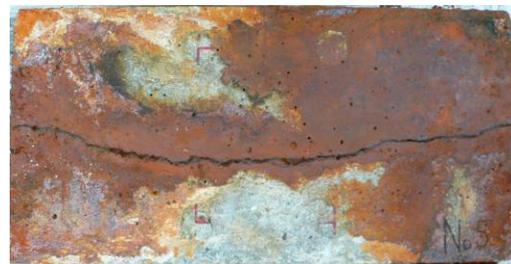
162 mg/cm²
0.54 mm, 0.52 mm

198 mg/cm²
0.50 mm, 0.68 mm

445 mg/cm²
0.94 mm, 0.93 mm

915 mg/cm²
1.52 mm, 1.58 mm

Figure B.3. Surface crack patterns of 150*150-C30

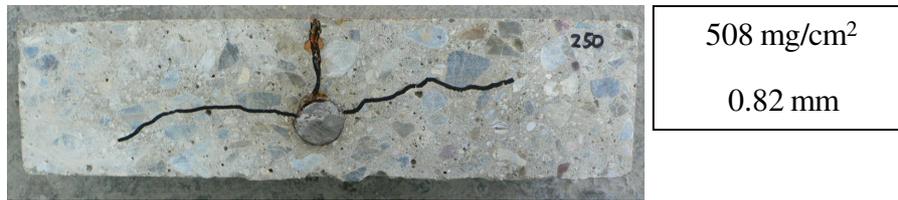
Figure B.30. Internal crack pattern of 250*250-C30

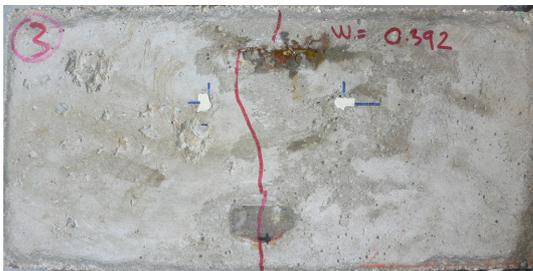
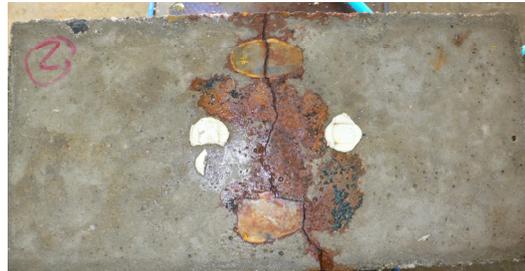
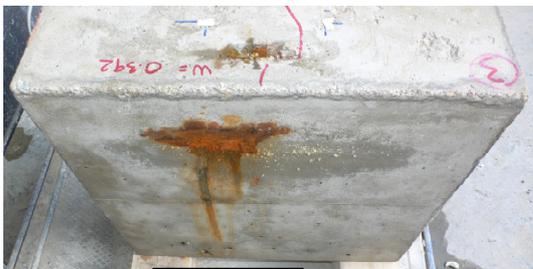
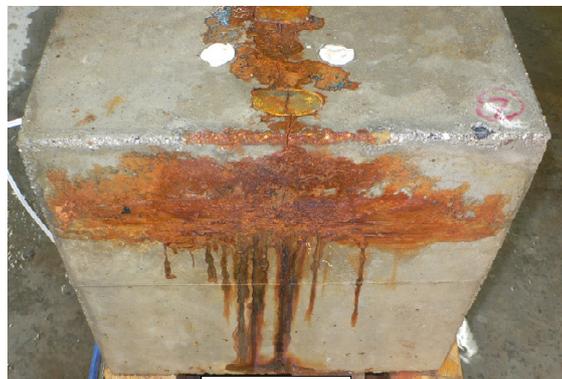
147 mg/cm²
0.15 mm

560 mg/cm²
0.53 mm

167 mg/cm²
0.39 mm

1014 mg/cm²
2.01 mm

Figure B.33. Surface crack pattern of 400*400-C30
