DETERIORATION CHARACTERISTICS OF Sn-BEARING STEEL BY ACCELERATED EXPOSURE TESTS

T. MORI^{1*}, M. HIROHATA¹, T. KAMIMURA³ and Y. ITOH^{1†}

¹*Graduate School of Engineering, Nagoya University, Japan*

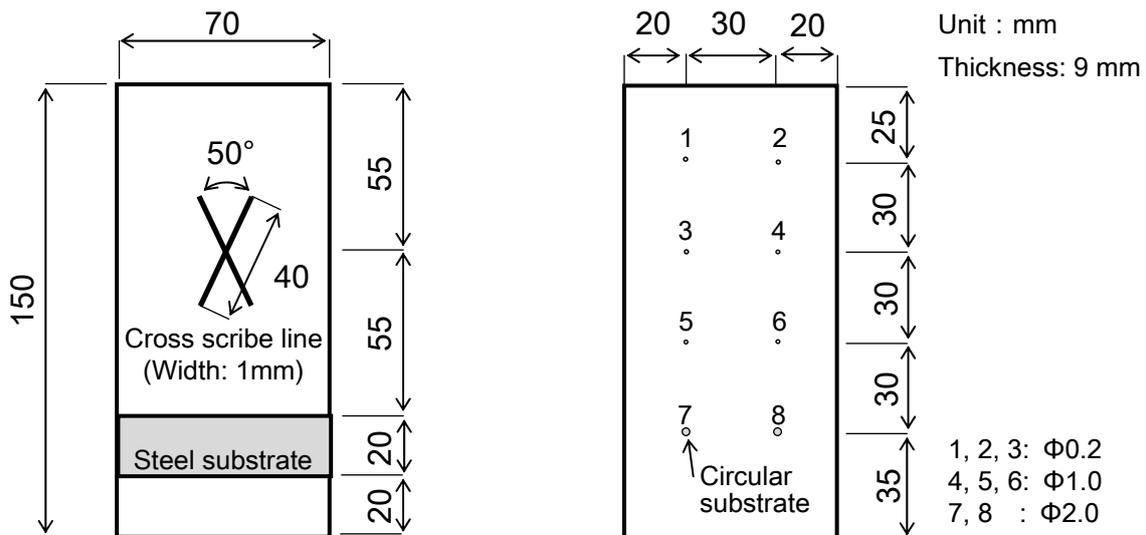
Figure 1: Shapes and dimensions of specimens

Artificial initial defects shown in Figure 1 were made on the painted specimens for investigating the deterioration behavior of the paint coating from the defects. In the cross cut specimen, the cross scribe defect simulated the scratch damage on the actual painting. The length and the width of the cross scribe line were 40 mm and 1 mm, respectively. The angle of the cross scribe lines was 50 degrees. The cross scribe lines reached to the substrate steels. 20 x 70 mm region at the lower part of the specimen was not coated for exposing the substrate steel. This simulated the corrosion

deterioration behavior from the discontinuous part of the paint coating such as the boundary between two members in bolted joints of actual steel bridges.

In the circular substrate specimen, the circular shape defects with different diameters (0.2, 1.0 and 2.0 mm) were made on the paint coating by using an end mill machine. The defects reached the substrate steel. This simulated the corrosion deterioration behavior from the pin-hole damage on the paint coating of actual steel bridges (Kim et al. 2007).

(a) Cross cut specimen

(b) Circular substrate specimen

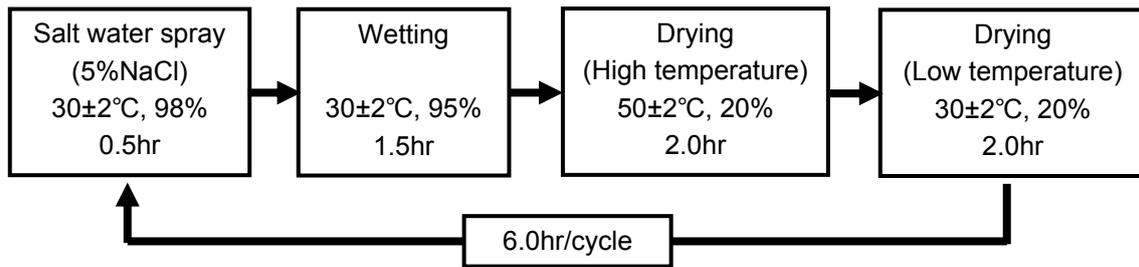
Figure 2: Accelerated exposure test condition

A series of the accelerated exposure tests with combined cycles of salt splaying, wetting and drying (S6 cycles) was carried out for 300 days (1200 cycles). Figure 2 shows the test conditions. The S6 cycles are specified in Japanese Industrial Standards (JIS K 5621) (Japanese Industrial Standards Committee 2006). The correlation was confirmed between the test results by the S6 cycles and the exposure tests on site (Fujiwara et al. 1997).

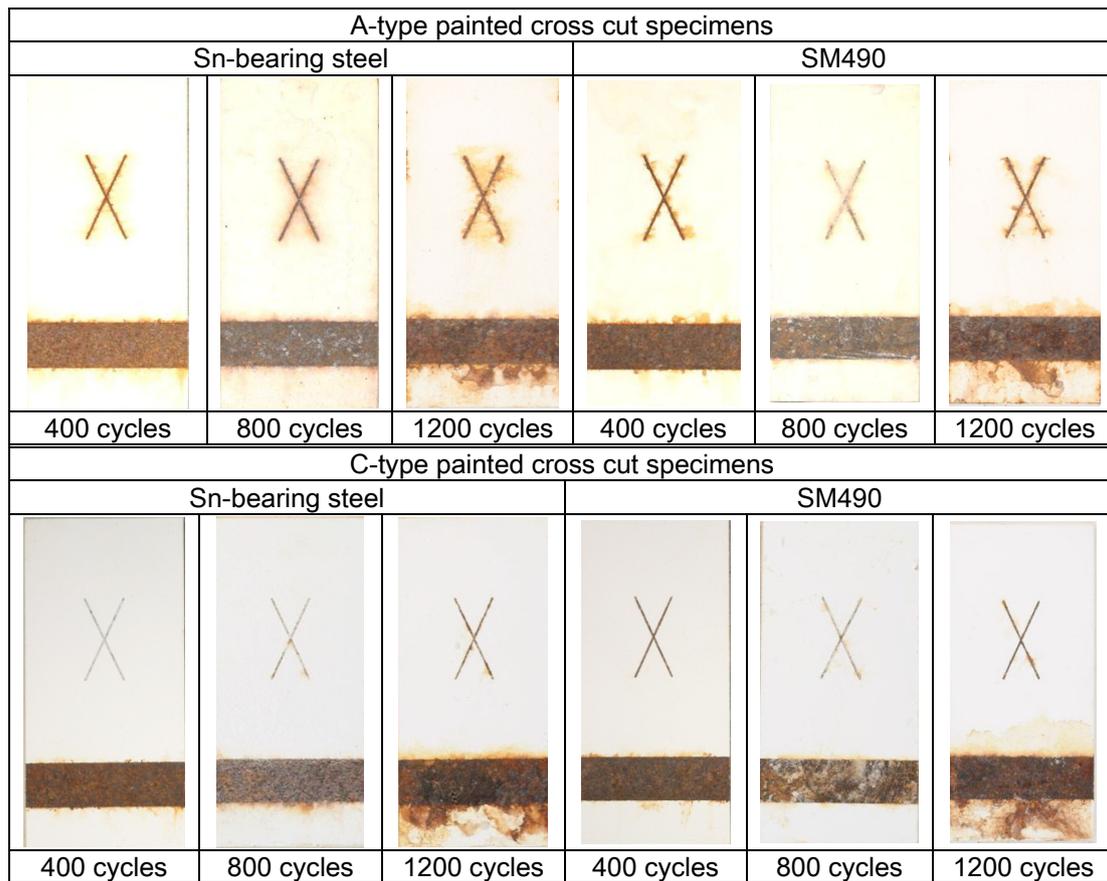
Figure 3: Appearance of specimens

Figure 3 shows the appearance of the cross cut specimens taken out from the test chamber by every 400 cycle. In the cases of the A-type painted specimens, the rust was formed around the cross scribe lines and the substrate region from 400 cycles in both the Sn-bearing steel and the SM490 steel. The amount of the rust increased with the test cycles. In the cases of the C-type painted specimens, the rust was scarcely formed around the cross scribe lines in both the Sn-bearing steel and the SM490 steel even after 1200 cycles. However, the amount of the rust around the substrate region spread with the test cycles. It could be seen that the rust under the substrate region of the Sn-bearing steel was fewer than that of the SM490 steel in both the A-type and the C-type painted specimens at 1200 cycles.

In the case of the circular substrate specimens, the degree of the rust was less than those of the cross cut specimens. Especially, almost no rust was observed in the C-type painted specimen regardless of the difference of the substrate steel.

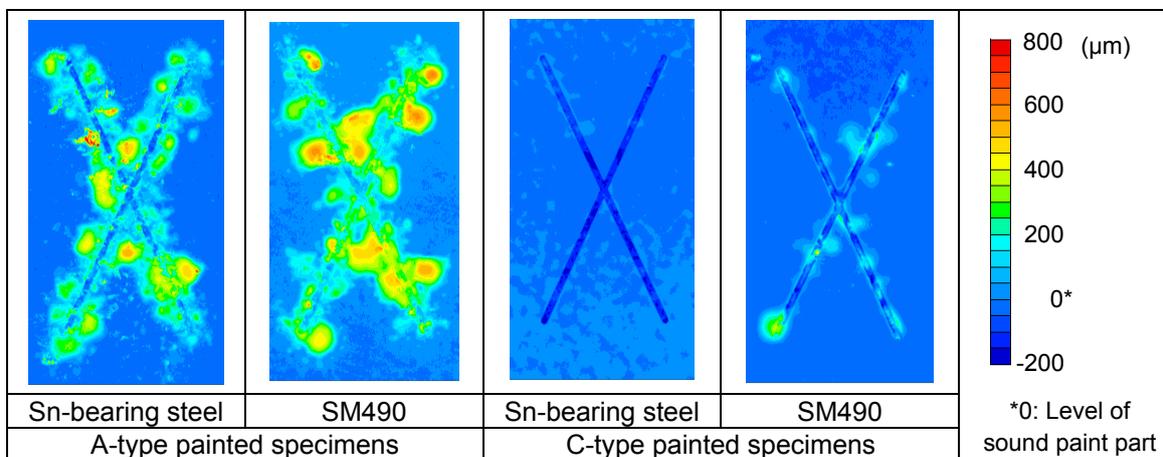
Figure 4: Blister around cross scribe regions (after the test of 1200 cycles)

The surface shape of the specimens after the accelerated exposure tests were measured by the laser displacement meter. The measured pitch was 0.3 mm in both the longitudinal and the transverse directions. Figure 4 shows examples of the measured results around the cross scribe regions in the specimens after the test of 1200 cycles. The area in which the height of blister of painting was over 50 μm from the level of sound painting region was determined as the blister area in this study.

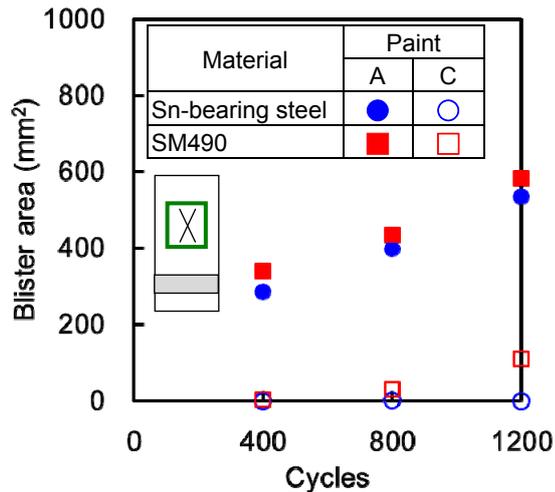
(a) Cross scribe region

Figure 5(a) shows the relationships between the blister areas from the cross scribe regions and the test cycles. The blister areas of the A-type painted specimens were larger than those of the C-type painted specimens. In the A-type painted specimens, the blister area of the Sn-bearing steel was smaller than that of the SM490 steel. The blister area of the Sn-bearing steel was around 92 % of that of the SM490 steel after 1200 cycles. In the C-type painted specimens, the blister areas of both the Sn-bearing steel and the SM490 steel were almost zero until 800 cycles. Although the blister area of the SM490 was increased, that of the Sn-bearing steel was not generated even after 1200 cycles.

- (1) In the A-type painted specimens, the blister area from the cross scribe paint defect of the Sn-bearing steel was around 92 % of that of the SM490 steel at 1200 cycles. In the C-type painted specimens, the blister areas from the cross scribe paint defect of both the Sn-bearing steel and the SM490 steel were not almost observed until 800 cycles. Although the blister of the SM490 was increased, that of the Sn-bearing steel was not generated even after 1200 cycles.

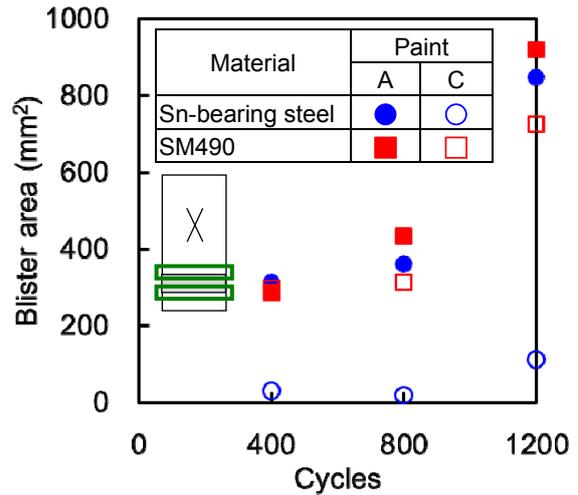
(b) Substrate region

Figure 5(b) shows the sum of the blister areas of the upper and lower parts of the substrate regions. In the A-type painted specimens, the blister area of the Sn-bearing steel was around 92 % of that of the SM490 steel at 1200 cycles as well as the cross scribe region. However, in the C-type painted specimens, a clear difference of the blister areas between the Sn-bearing steel and the SM490 steel could be confirmed. The difference of the blister areas between the Sn-bearing steel and the SM490 steel became larger with an increase of the test cycle. The blister area of the Sn-bearing steel was around 16 % of that of the SM490 steel after 1200 cycles.

- (2) In the A-type painted specimens, the blister area from the boundary between the painted and not painted regions of the Sn-bearing steel was around 92 % of that of the SM490 steel at 1200 cycles. In the C-type painted specimens, the difference of blister areas between the Sn-bearing steel and the SM490 steel became larger with increase of the test cycle. The blister area from the boundary region of the Sn-bearing steel was around 16 % of that of the SM490 steel at 1200 cycles.

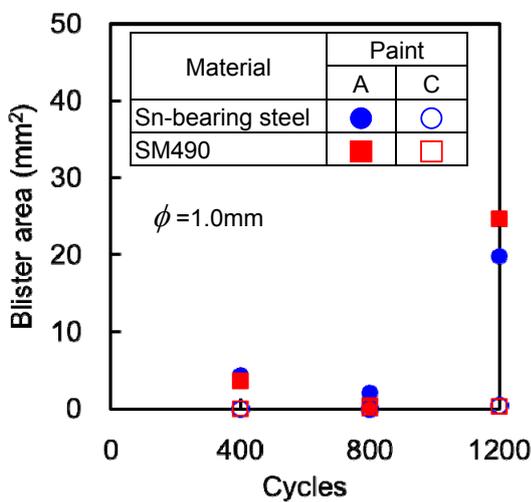
(c) Circular substrate region with diameter of 1.0 mm

Figures 5(c) and (d) show the relationships between the blister areas from the circular substrates regions with diameters of 1.0 mm and 2.0 mm and the test cycles respectively. The scarce blister could be observed around the circular substrate region with diameters of 0.2 mm.

In the A-type painted specimens, the blister areas of the Sn-bearing steel around the circular substrates with diameters of 1.0 mm and 2.0 mm were around 80 % and 68 % of those of the SM490 steel at 1200 cycles respectively. In the C-type painted specimens, the blister hardly occurred even though the diameter of the circular defect was 2.0 mm at the 1200 cycles

- (3) In the A-type painted specimens, the blister areas of the Sn-bearing steel around the circular substrates with diameters of 1.0 mm and 2.0 mm were around 80 % and 68 % of those of the SM490 steels at 1200 cycles respectively. The scarce blister could be observed around the circular substrate region with diameters of 0.2 mm. In the C-type painted specimens, the blister hardly occurred even though the diameter of the circular defect was 2.0 mm at the 1200 cycles.
