Soil Erosion and Conservation in Western Kenya

Report of the Research Project, No. (A) 15253006 (2003-2005)

Edited by

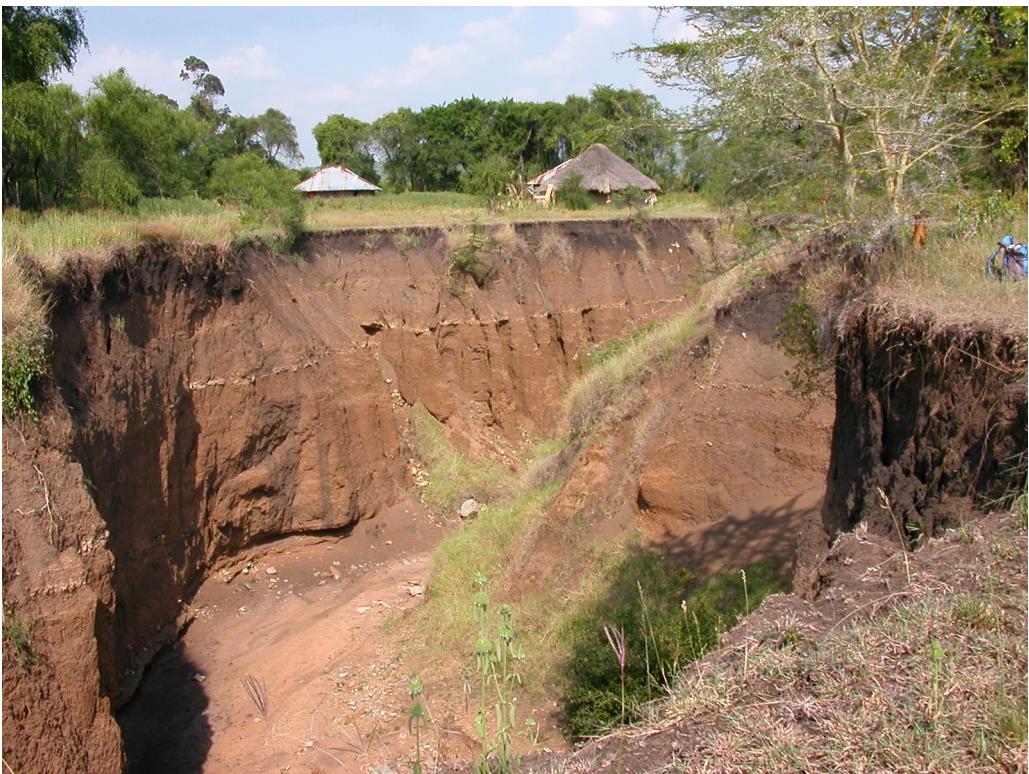
Plate II-5. Photograph of a perpendicular bank (c.14 m in height) of the Awach-Kano gully. (July 2003)

by streamflow and mass wasting. Gullies in Awach-Kano and Paponditi study sites represent this type, which is therefore called hereafter “Awach type”. In particular in the Awach-Kano site (Fig. 3-2a), significant portion of the gully exhibits its depth up to 14 m and width less than 15 m. Due to its steep geomorphic condition, slumping of bank wall occurs in places (Plate II-5).

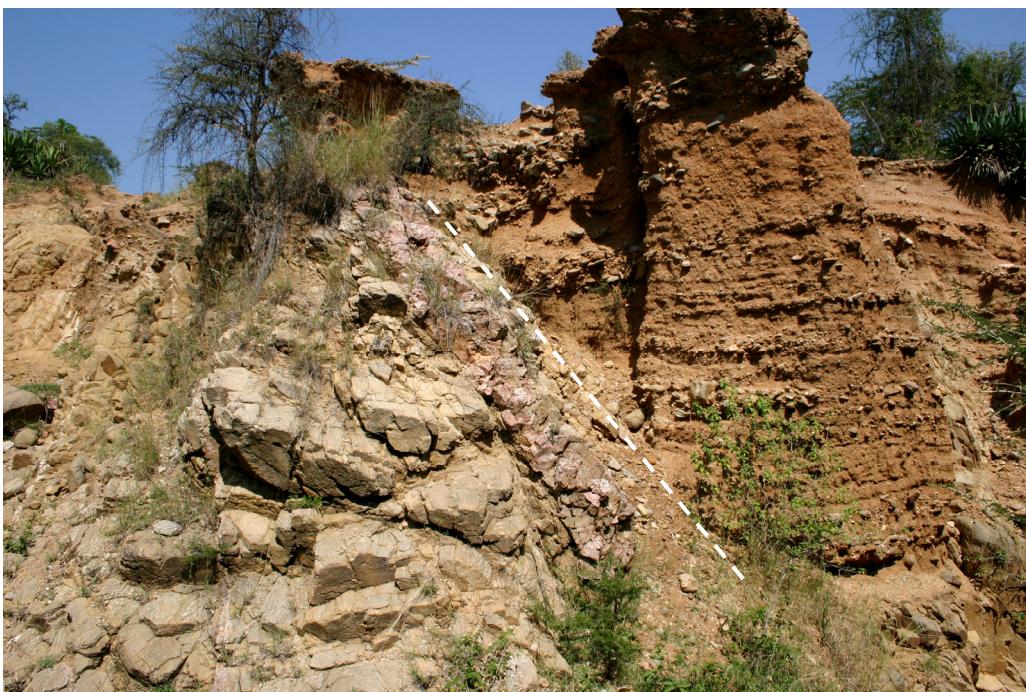
Plate II-8. Photograph of an upstream part of the Nyalunya gully. A broken line indicates unconformity between the Archaean granitoid (left) and the alluvium (right). The sidewall is 4 m high. (August 2005)

At the upstream of Nyalunya (Nyalunya-A in Fig. 3-7), Ragen and Sondu-Miriu (Fig. 3-8), the sediments deposited unconformably on Archaean granitoid (Plate II-8).

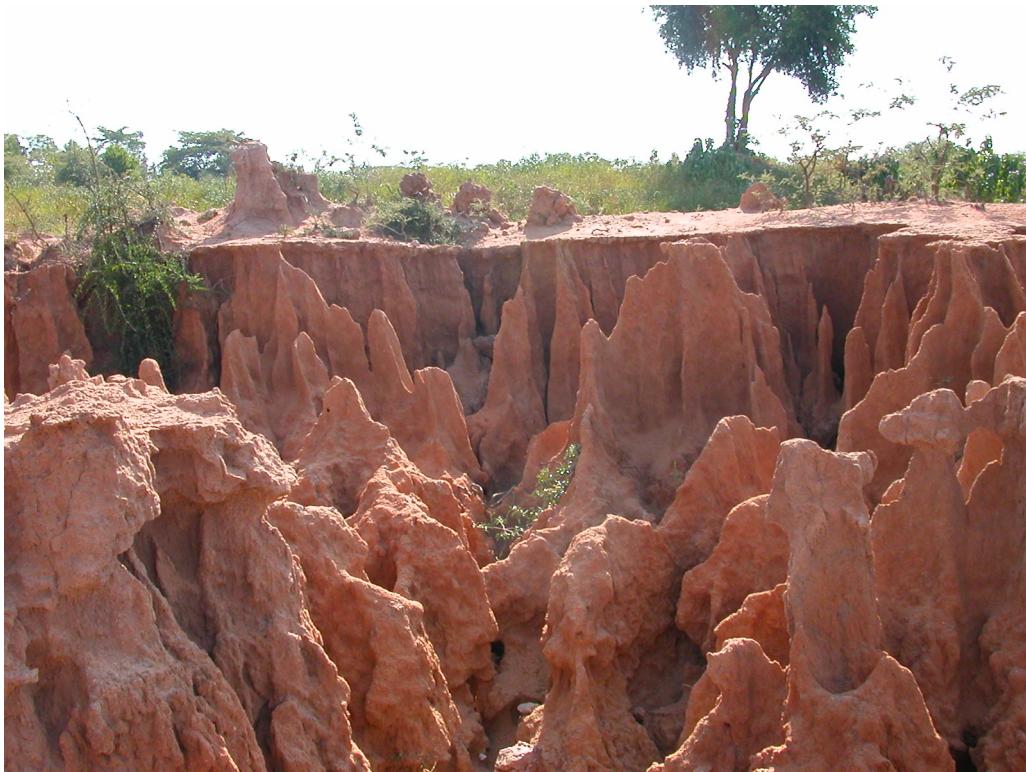
Plate II-13. Photograph of earth pillars (c. 3 m in height), the Sondu-Miriu gully. (July 2003)
