OZONE-INDUCED CRACK ON BASE-ISOLATED NATURAL RUBBER BEARING SUBJECTED TO EXTERNAL LOADS AND ITS REPAIR

Yoshito Itoh¹, Mikihiro Hirohata² and Katsuyuki Fujimoto³

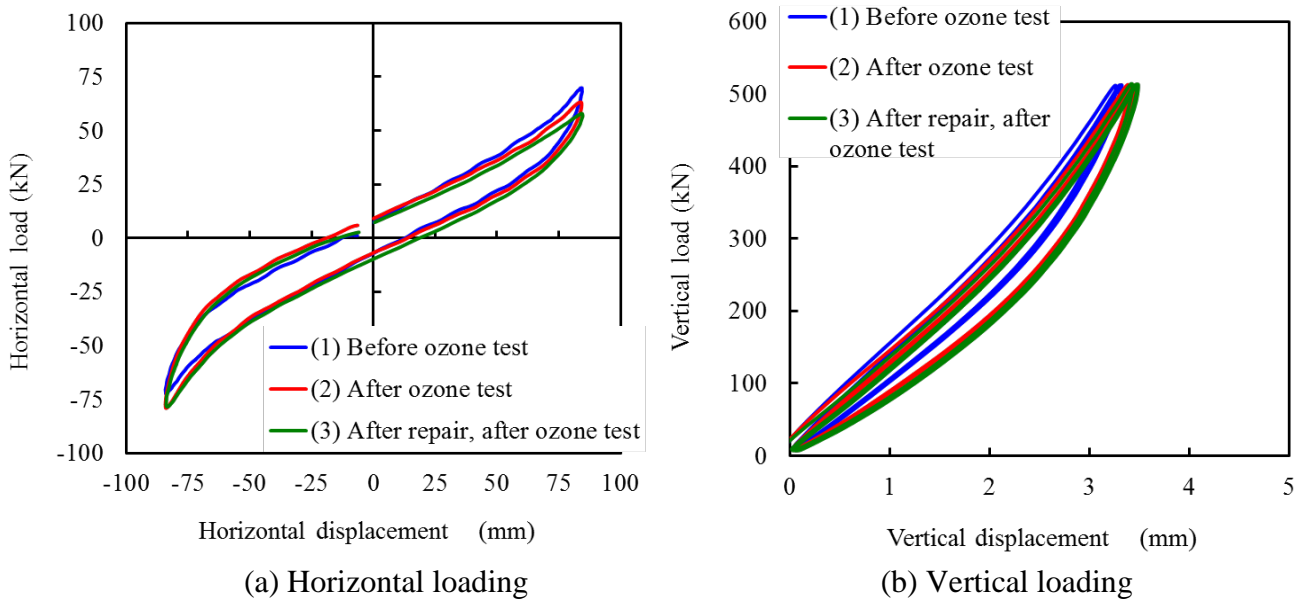
Figure 9: Results of loading experiments

Figure 9 shows the results of loading experiments. The vertical displacement of the bearing specimen with small and large cracks occurred by the first accelerated exposure experiment (state (2)) increased by 4 % from that of the virgin state (state (1)). The vertical displacement of the bearing specimen of which the cracks were repaired and after the second accelerated exposure experiment (state (3)) increased by 3% from the virgin state (state (1)). The horizontal stiffness of them were almost the same as that of the virgin state. All of the three states satisfied the design specifications of vertical displacement and horizontal stiffness. No crack propagation could be observed by the loading experiment. It might be thought that the influence of cracks generated by the accelerated exposure experiments on the mechanical performances of bearing specimen was not so large because the cracks did not reach the rubber layers inside the specimen.
