# Lifecycle Performance Assessment Technology for Port Steel Structures with a Focus on Post-repair Performance

by Yoshito Itoh, Professor, Yasuo Kitane, Associate Professor, and Mikihiro Hirohata, Assistant Professor; Civil Engineering, Graduate School of Engineering, Nagoya University

## Prolongation of the Service Life of Aging Port/Harbor Steel Structures

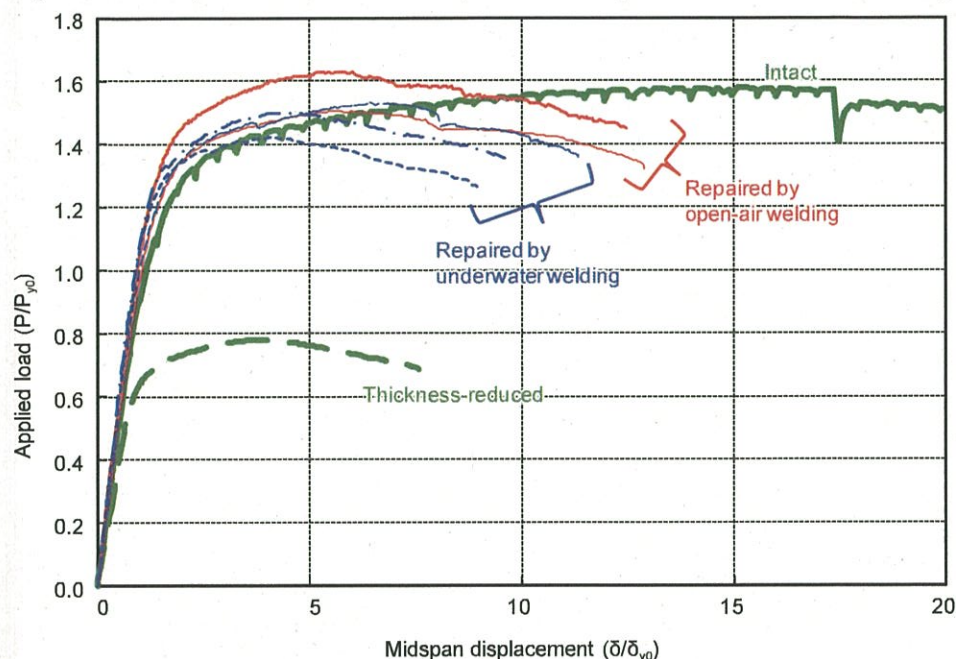
**Fig. 3 Load-Displacement Relationships of Steel Pipes under Flexural Loading**

curred, the corresponding ductility decreased from pre-corrosion levels. Fig. 3 shows the load-displacement curve obtained from the flexural loading tests.

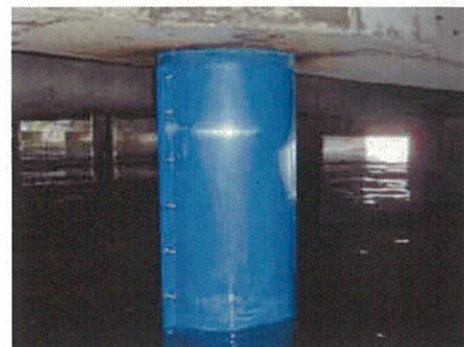
**Photo 1** Steel pipe pile repaired by patch plates with petrolatum coating and FRP cover

In order to show lifecycle performance, it is necessary to understand post-repair corrosion resistance. In the current practice, corrosion-protection coatings are applied to steel pipe piles that have been repaired by means of steel patch plate welding. Photo 1 shows an example of such steel pipe piles to which petrolatum coating was applied and an FRP cover over the coating had been attached. It is accepted that such a corrosion protection is effective for about 20 years; however, in cases when an FRP cover has been damaged by floating objects and a part of petrolatum coating has been gouged away, the repaired section is once again exposed to the corrosive environment. While many research results are available that pertain to the corrosion characteristics of steel members in seawater, less research has been conducted that compares general sections of steel members with welded joints in order to demonstrate differences in corrosion characteristics.
