## DETERIORATION CHARACTERISTICS OF ANTI-CORROSIVE METALLIC COATINGS UNDER ACID RAIN AND APPLICATION OF PAINT REPAIR

### Abstract

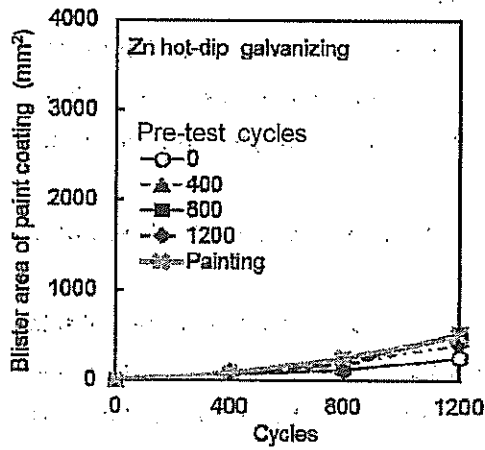
(a) Zn hot-dip galvanizing

In the case of the Zn hot-dip galvanizing (Fig. 6(a)), the differences of the changes of the blister area are small regardless of the cycles of the pre-test for deteriorating the metallic coating. They are almost the same

as the case that the specimens directly painted on the steel. This is because hardly any coating remained until 400 cycles in the pre-test. In the cases of the Zn-Al alloys and the Zn-Al pseudo-alloys (Fig. 6 (b) and (c)), the deteriorations of only the specimens painted on the virgin metallic coatings increase from 800 cycles.

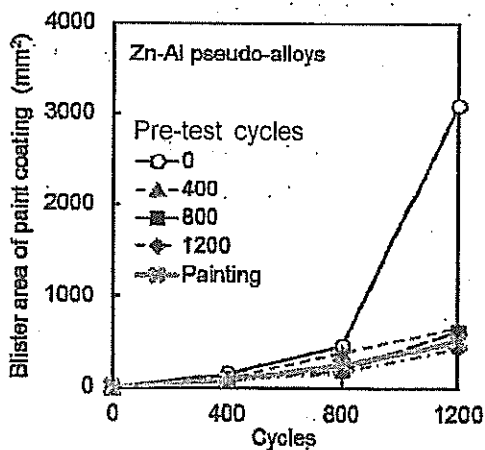
(b) Zn-Al alloys

(c) Zn-Al pseudo-alloys

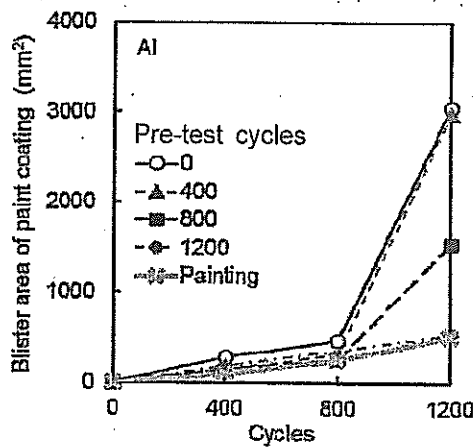
(d) Al alloys

Fig. 6 Blister area

For evaluating the deterioration of the paints, the blister areas shown in Fig. 6 are noted. The blister area is defined as the area in which the thickness of the paint coating becomes 150 $\mu$ m larger than that in the virgin state.

In the case of the Al (Fig. 6 (d)), longer the cycles in the pre-test are, larger the blister area become.

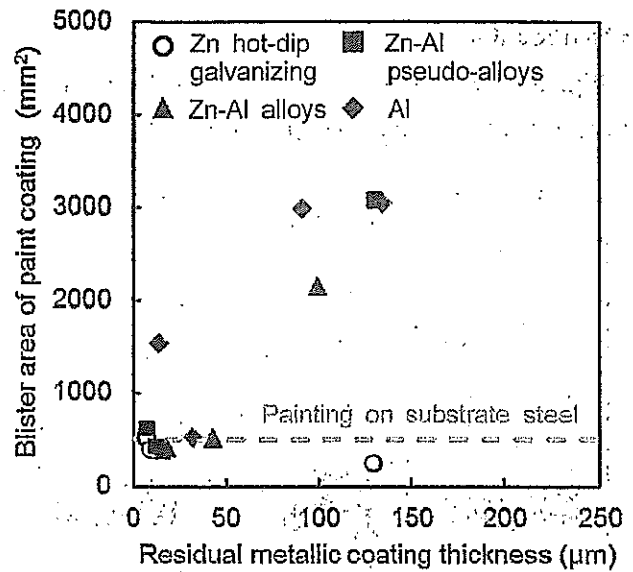
Fig.7 Relationship between residual coating thickness

The results indicate that the degree of the residual metallic coating in the pre-test affects the deterioration of the repair paint coatings. For investigating this effect, the relationship between the residual metallic coating thickness by the pre-test and the blister area of the repair paint coatings after finishing the 1200 cycles accelerated exposure test is shown in Fig. 7.

The residual metallic coatings largely affect the durability of the repair paints on them. Although the degree of the effect depends on the types of the metallic coatings, there is a risk that the durability of the repair paints becomes low due to the residual metallic coatings.
